## Battlemead Common: Groundwater Monitoring in the Willow Fields and flow in the White Brook

Ann Darracott,  
Maidenhead Civic Society, December 2020

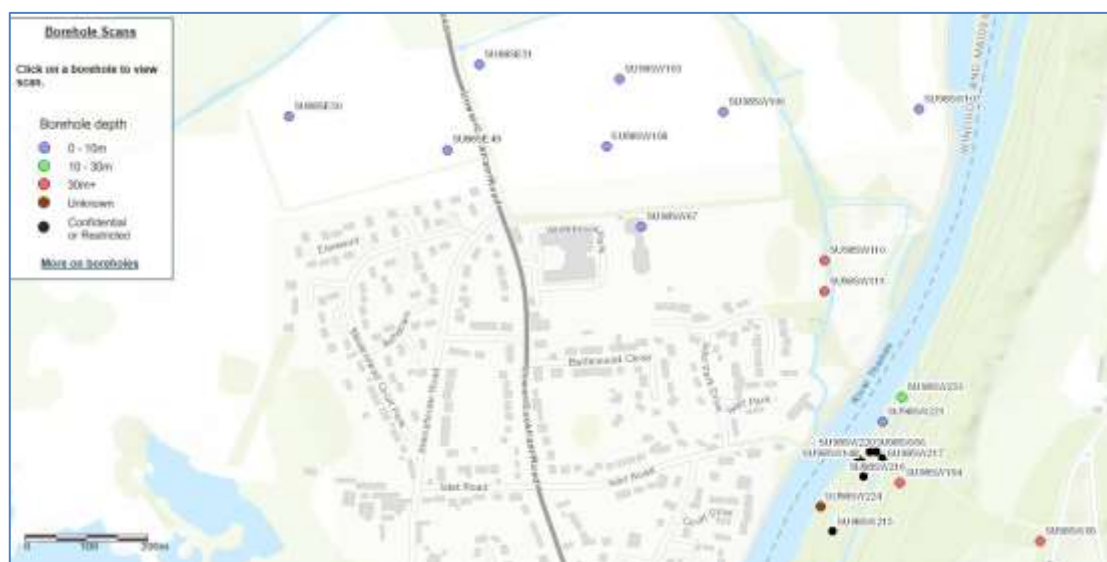
*Boreholes drilled in the area of Battlemead Common*

An online map produced by the British Geological Survey shows the location of boreholes in Battlemead Common, Widbrook Common, and the east bank of the Thames.<sup>1</sup> It is possible the shallow boreholes (drilled to 10m) on the two commons were linked to investigations for the North Maidenhead Flood Bund.

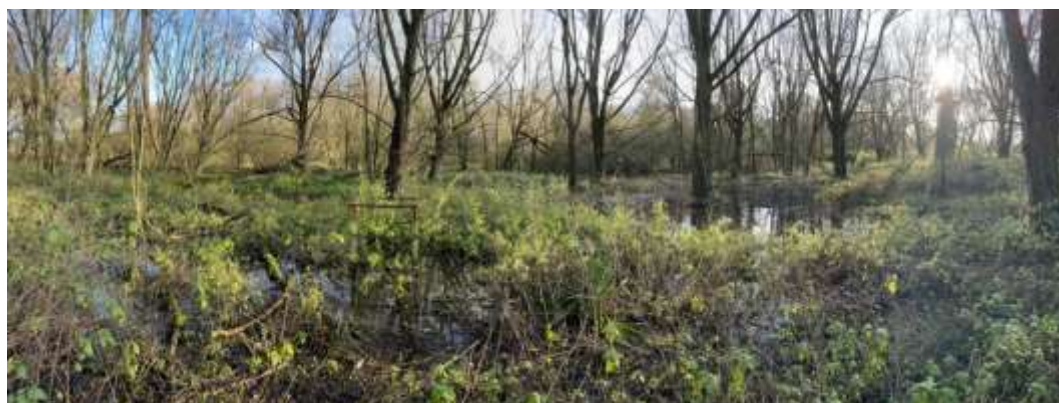
*Observation borehole in the Willow Fields with overflowing backwater – December 2020*

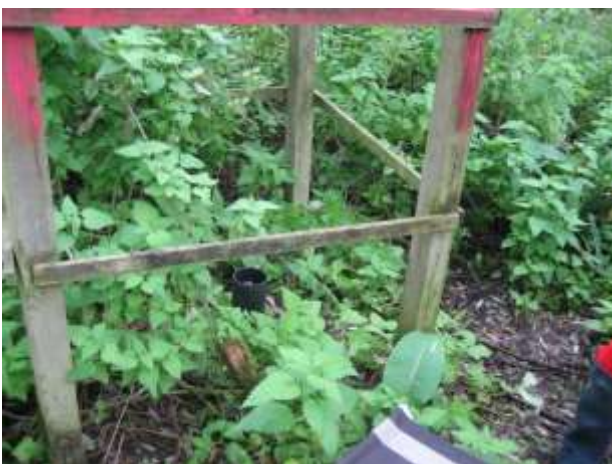
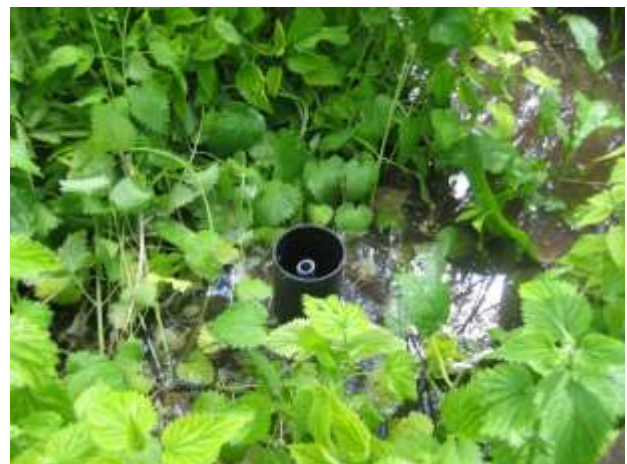
*Borehole SU98SW110 and close-up showing the observation tube within the outer casing.*

*nb: Outer casing protrudes 300mm above ground level. Gravel within outer casing is 1.4m below ground level. Bottom of observation tube is 2.55m below top of the tube. Ground elevation at the site estimated to be 25m AOD (from 1:25,000 OS map). All measurements of depth to GW are relative to top edge of outer protective casing. Outer casing is approximately 27.5 mm higher than inner observation tube.*

To help understand the hydrology of the willow fields which has, in the winter, extensive backwaters, it was decided to monitor the borehole on a monthly basis, to establish groundwater depth (GW). An initial test was undertaken in November 2019 and then, beginning in January 2020, data were collected monthly. Initially an electronic dip sensor was used and then subsequently one was improvised because of equipment issues.

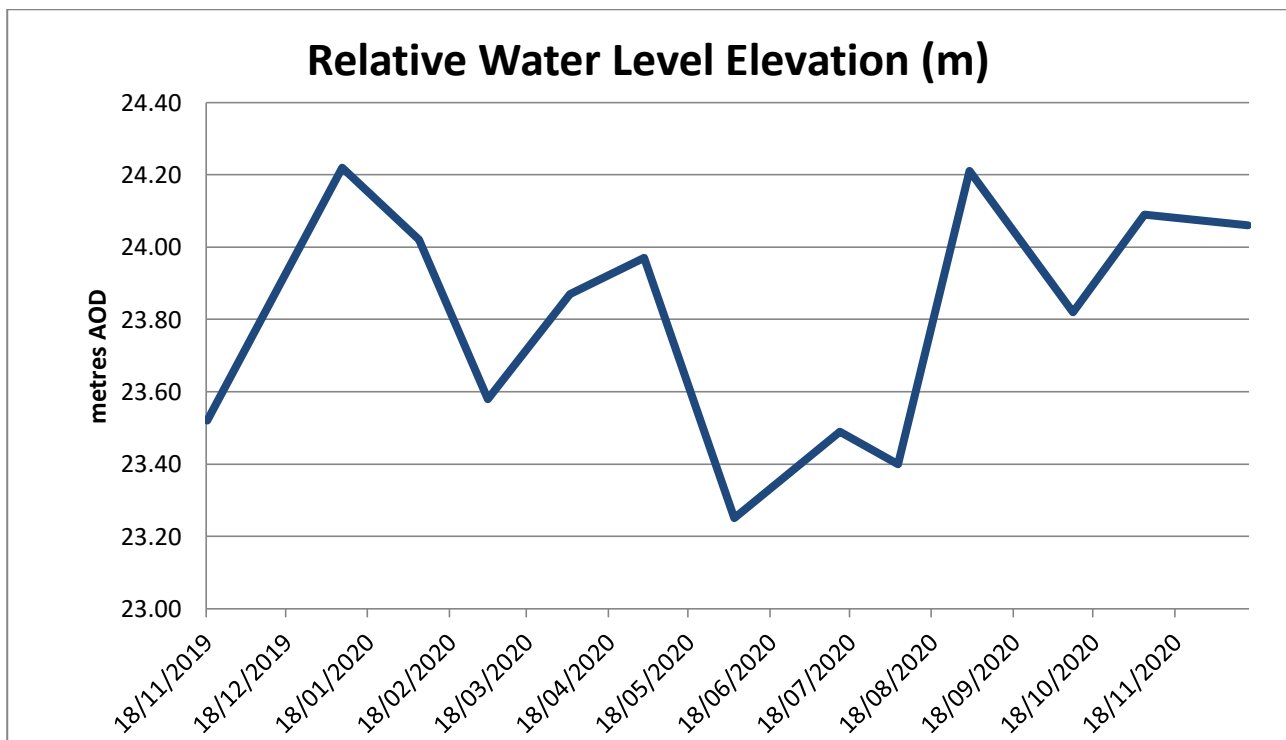
DATE	GROUND WATER LEVEL (Depth below outer casing top in m)	GWL AOD	CHANGE RELATIVE TO PREVIOUS MONTH (In mm. +ve = a rise; -ve = a drop)
18/11/2019	1.78	23.52	
08/01/2020	1.08	24.22	700
06/02/2020	1.28	24.02	-200
03/03/2020	1.72	23.58	-440
03/04/2020	1.43	23.87	290
01/05/2020	1.33	23.97	100
04/06/2020	2.05	23.25	-720
14/07/2020	1.81	23.49	240
05/08/2020	1.90	23.40	-90
01/09/2020	1.09	24.21	810
10/10/2020	1.48	23.82	-390
06/11/2020	1.21	24.09	270
15/12/2020	1.24	24.06	-30

As might be expected the ground water level rises in the winter and drops in the summer and is broadly related to the presence or absence of surface water in the backwaters. In 2020 the minimum GW depth recorded was 78cm (January) and the maximum 165cm (June).

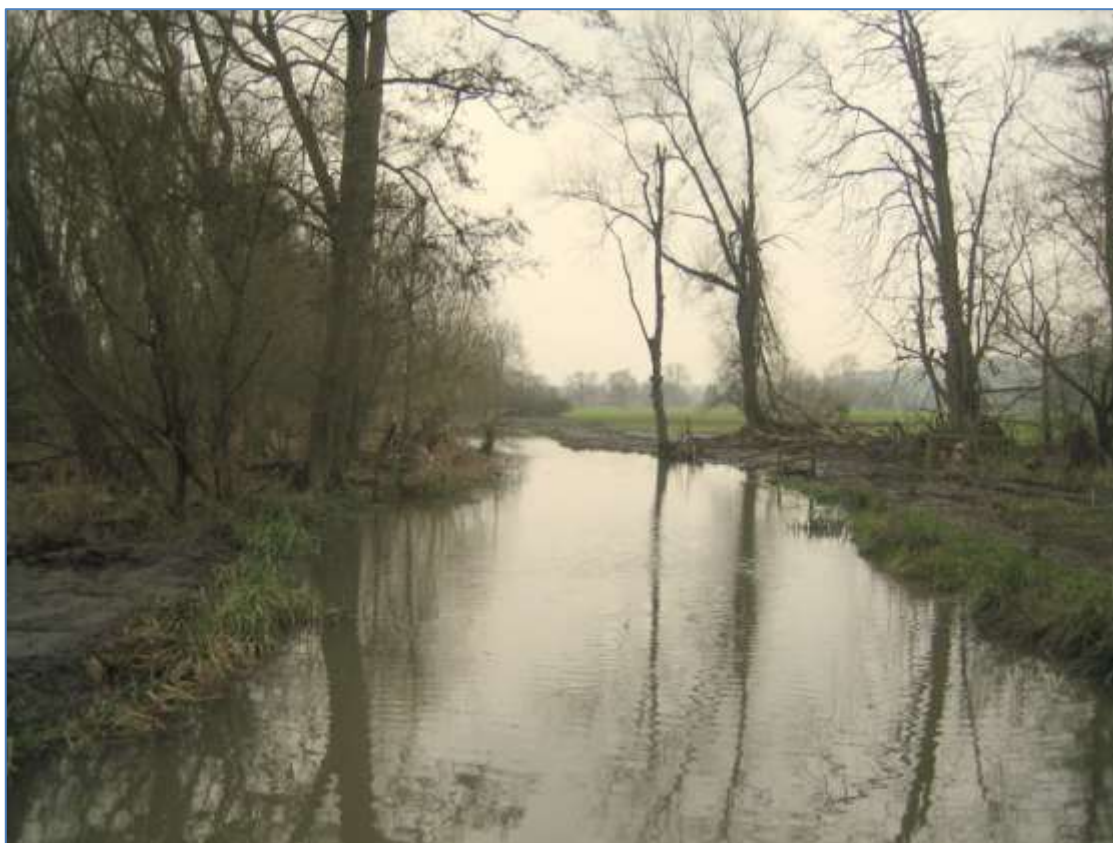
*The White Brook after the last desilting, February 2011- the east bank of the brook, seen in the distance, is now wetland. This bank was poached by cattle in the past*

There has been no significant desilting of the White Brook, on what is now Battlemead Common, since 2011 (see photo below), and both silt and reeds have accumulated in the brook over the intervening years. In the past silt was spread on the bank, helping to restore damage due to poaching by cattle; in the distant past it was even seeded. The absence of such restoration has led to the creation of the wetlands on the East Field of Battlemead Common.

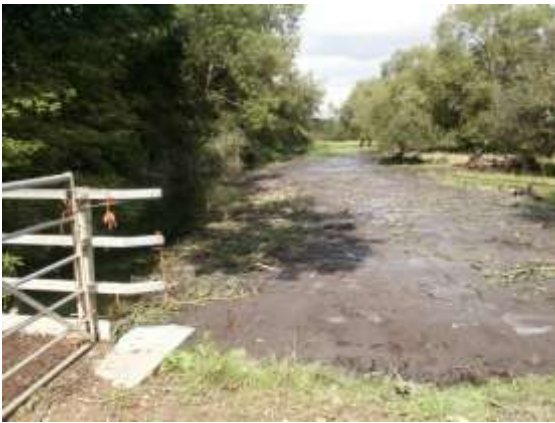
Silt spread on the east bank of the White Brook during desilting in August 2004 in the East Field

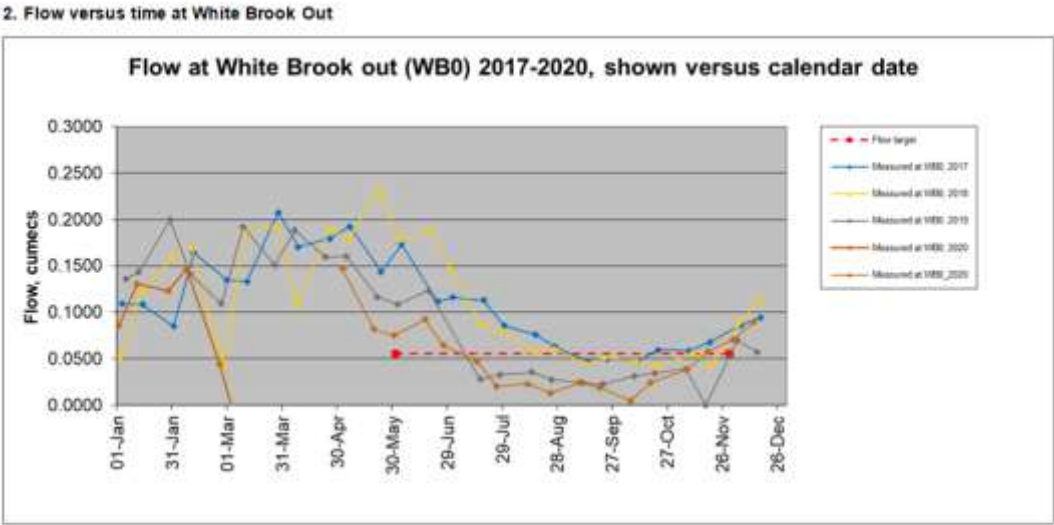
*Flow in the White Brook in 2020 compared to previous years: monitoring point just east of the junction with Strandwater (courtesy of Maidenhead Waterways)*

Data indicates that flow in the White Brook has slowed in 2019 and in 2020, compared to earlier years, and in the warmer months has dropped below target flow (see graph).<sup>4</sup> Due to covid restrictions attempts by volunteers from Maidenhead Waterways to maintain flow by the regular manual removal of reeds and aquatic vegetation such as Fools Watercress, from different sections of the brook, was more limited in 2020. On Battlemead in March 2020 two fallen trees were removed from the brook and also a trial desilting of 30m took place. These actions did not improve 2020 flow compared to 2019, in fact the data indicates there was even less flow.
