## **Number of Invertebrate species recorded at three different sites just before, during and after the Byofix trial in Maidenhead's Waterway from Spring to Autumn 2021**

In 2021 on advice from the Environment Agency, a trial of Byofix, that uses bacteria to control blanket weed (Zygometalean algae) by reducing nutrient and pollutant levels in the water, was begun on 21st March, some months earlier than the 2020 Dyofix (blue dye) trial. The blue dye treatment creates shade to control weed growth but there was an indication that it had an impact on faunal diversity in the new waterway.<sup>1</sup> The Byofix was administered by Maidenhead Waterways' volunteers every two weeks from 21st March to 5<sup>th</sup> September (13 doses). Before each dose a survey of aquatic fauna was carried out at three of the same sites used last year for the Dyofix treatment i.e.

Ann Darracott  
Maidenhead Civic Society  
28<sup>th</sup> October 2021

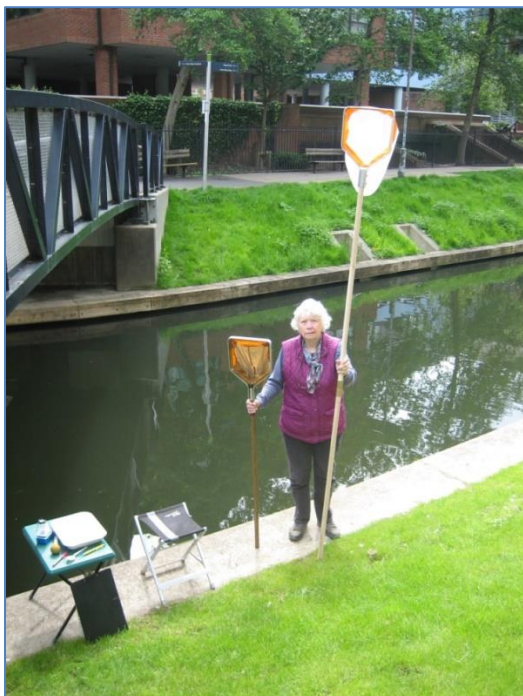
*Short-handled net used initially replaced by a bigger net on 29th May*

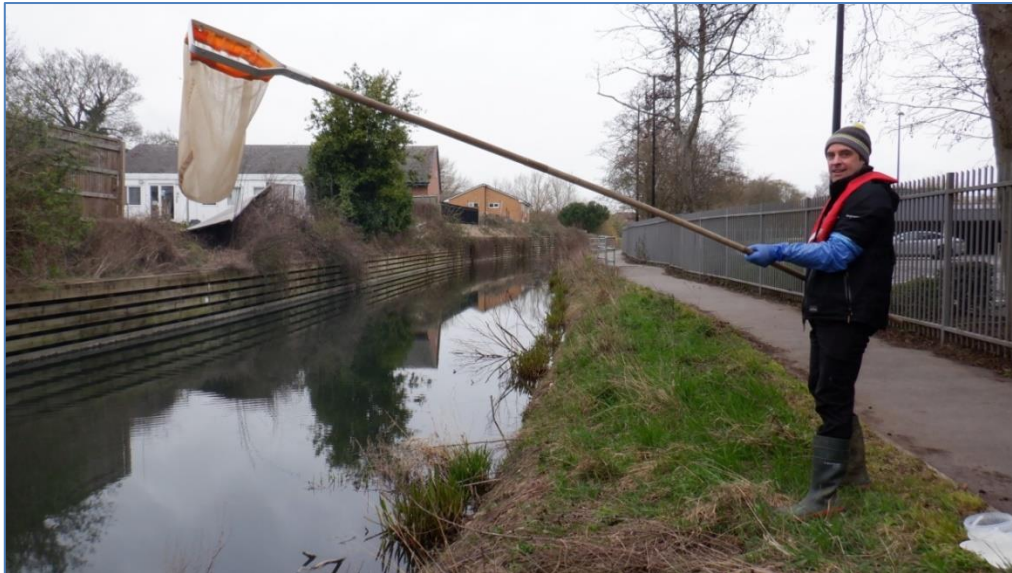
*Tim Flood of the Environment Agency demonstrating the net he used*

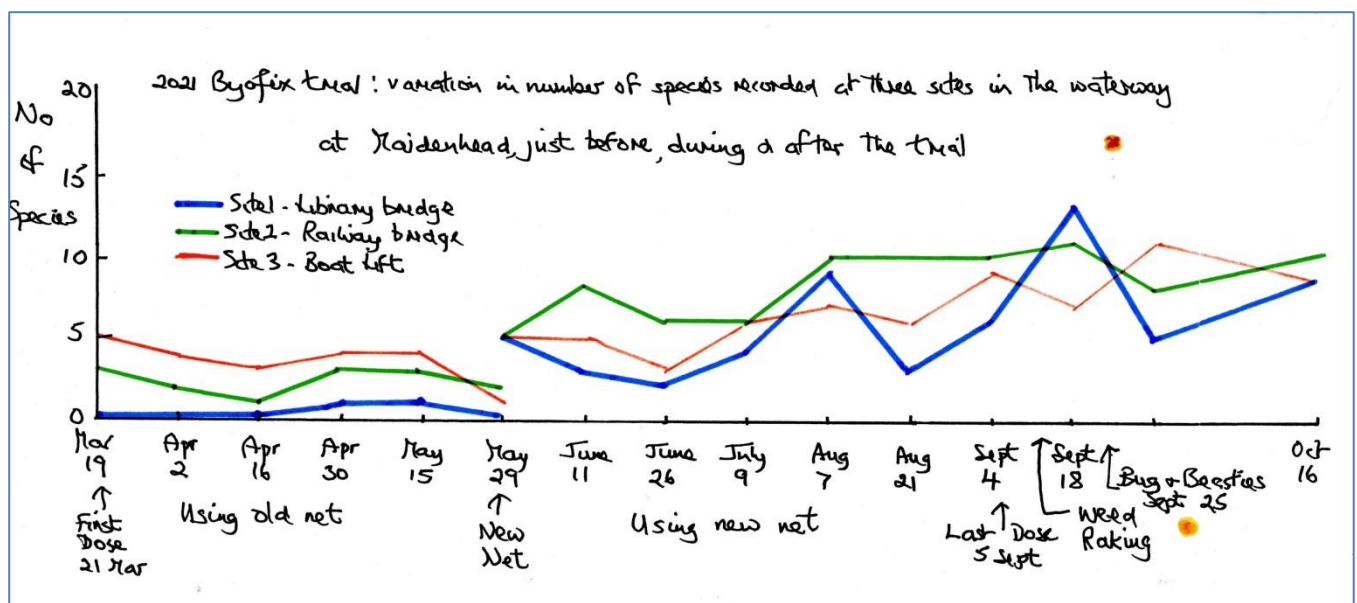
Environment Agency judges the quality of the aquatic environment by the faunal diversity of the invertebrates present. Therefore the number of invertebrates sampled over the survey period at the three sites was graphed based on data in Table 1 below. The numbers are conservative as, for example, no attempt was made to differentiate the different species of snail apart from the ramshorn snail.

The results show the following:

- 1) The larger net gave a more accurate idea of the faunal diversity of the habitat, as it could sample into deeper water and reach the bottom.
- 2) Generally, the Library Bridge site exhibited the least diversity.
- 3) Weed raking had most effect on diversity at the Library Bridge site whereas the Railway Bridge and Boat Lift site seemed unaffected.
- 4) That the diversity recorded is conservative is confirmed by the greater number of invertebrates recorded on 25<sup>th</sup> September during a dipping activity for primary school children (see yellow dot on graph). This was due to the use of four nets.

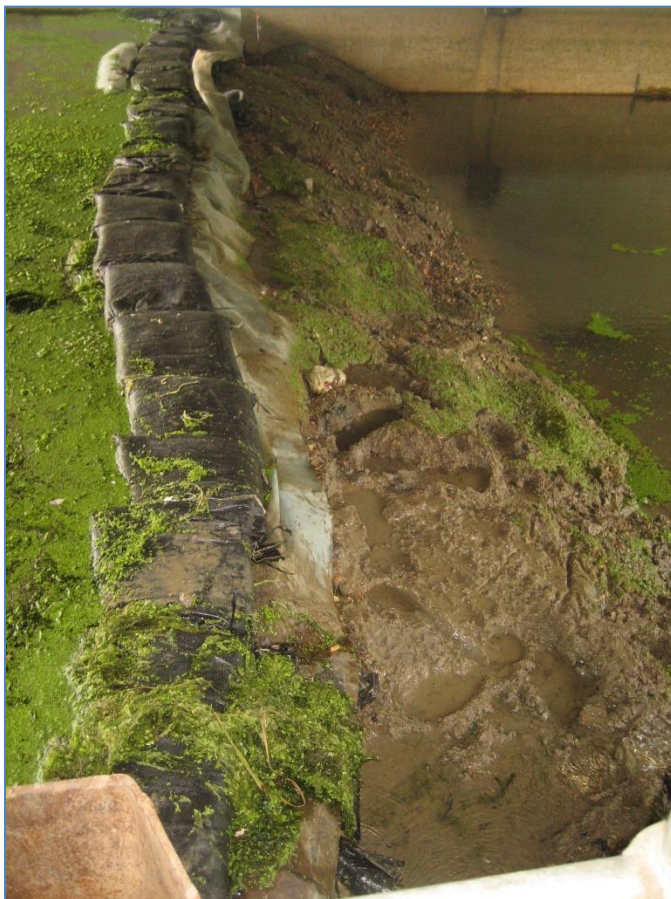
Earlier in the season the Green Lane Pool next to the Boat Lift site was subject to growth of blanket weed due to inoculation from the shallow Moor Cut which was in contact with it. The construction of a bund at the junction has resolved this problem.

*Bund constructed to prevent water backing into Moor Cut from the Green Lane Pool.*

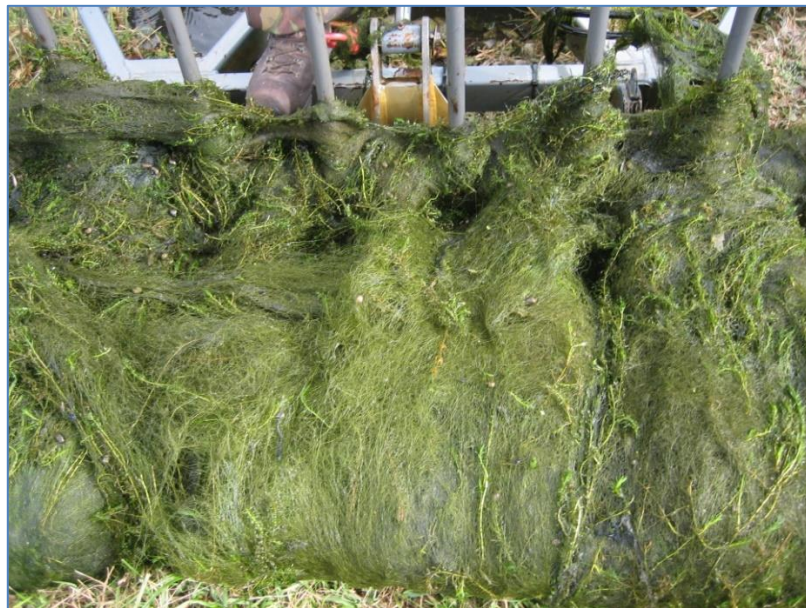
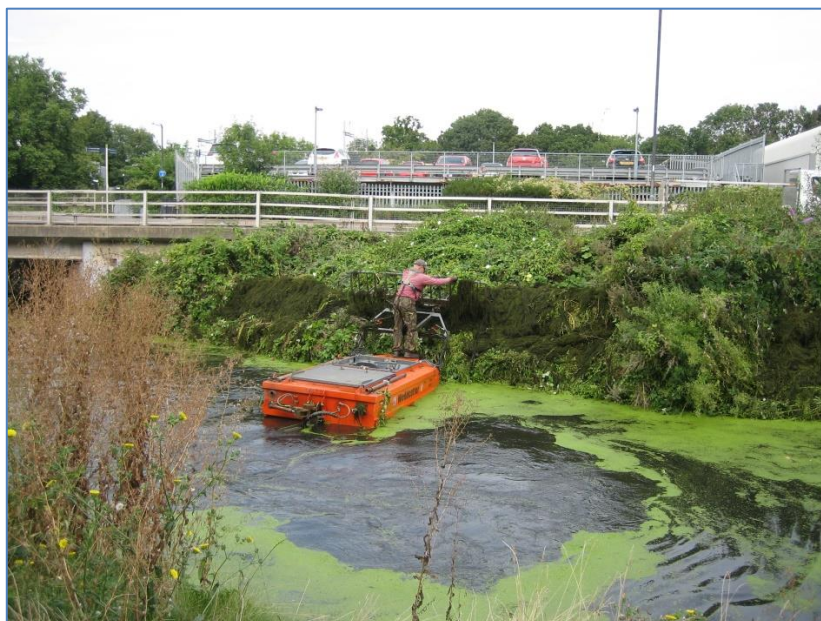
It is estimated that raking by the “weed cutter” machine has removed 30-35 tons of weed from the waterway. This was to improve conditions for the canoe cavalcade on 25<sup>th</sup> September. As many aquatic organisms are attached to the weed it means these have mostly been lost and this is largely reflected in the reduced biodiversity. The numbers and species types recorded from a few strands of weed (*E. nuttallii* & blanket weed – see table below) give an idea of what the removal of 30-35 tons will have done. Photos (*upper*) show the weed on the rake from which the few strands were taken; and (*lower*) weed being deposited on the bank. Suggest in future the operator arranges for more weed to trail into the water to allow fauna to escape.
